TRADING AS **PORTLAND ALUMINIUM**

# BUSHFIRE MITIGATION PLAN

## 2024-2025

Rev C.

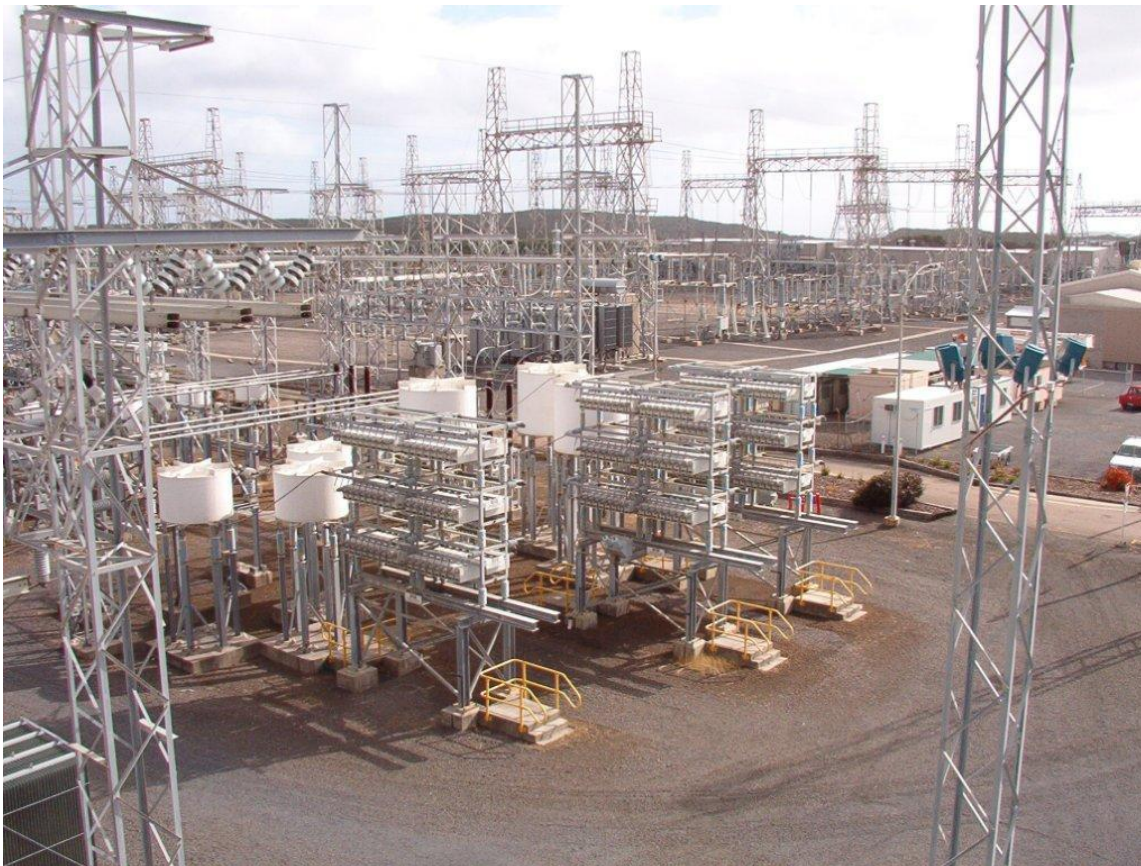
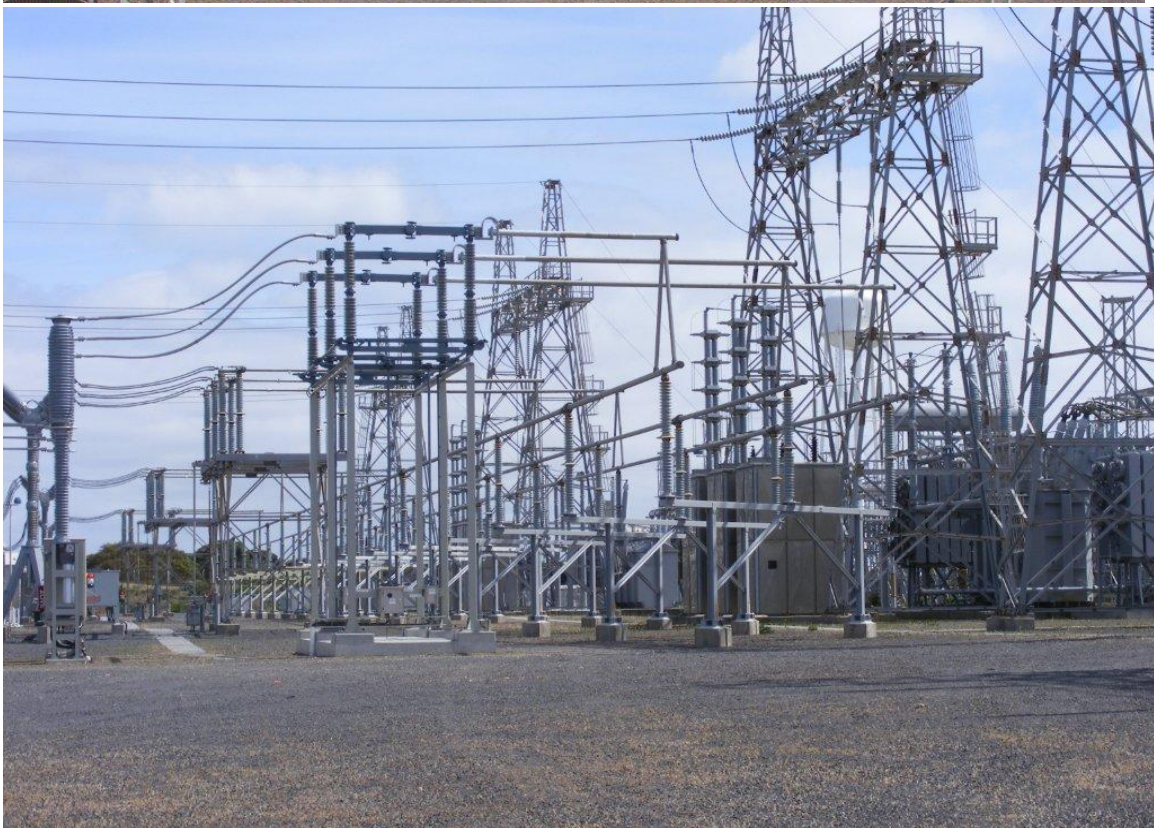
**PORTLAND MAIN SWITCHYARD ILLUSTRATING LACK OF SIGNIFICANT VEGETATION**

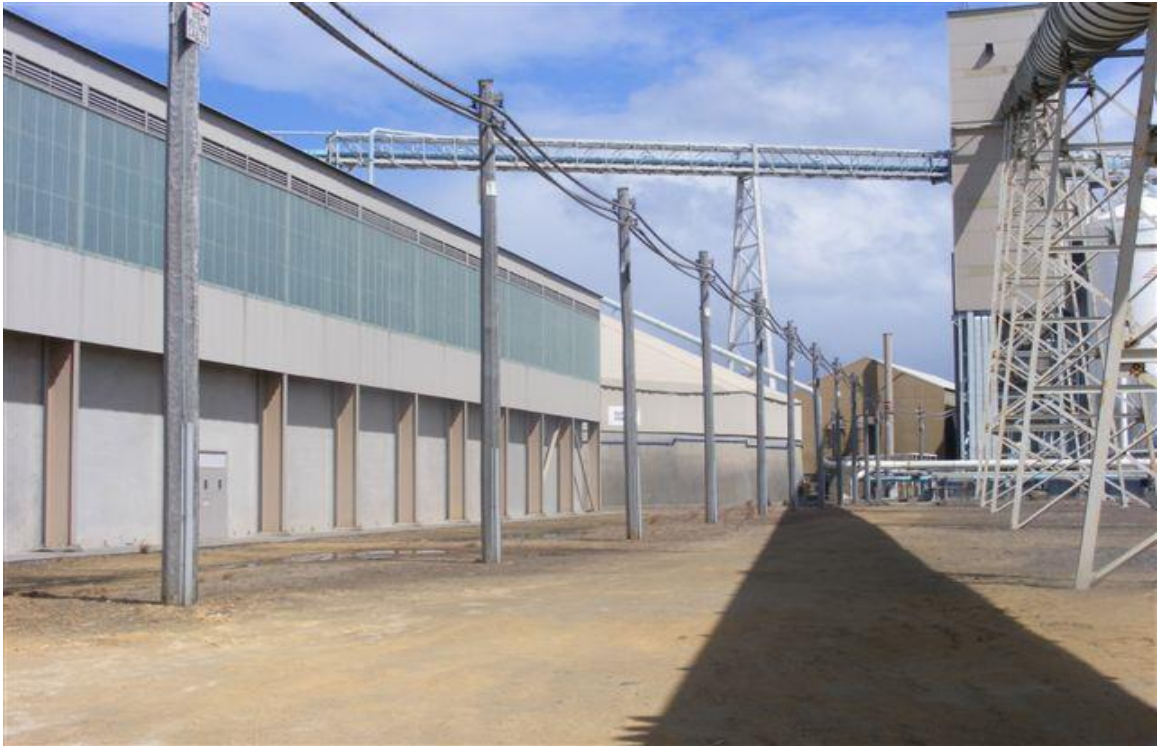
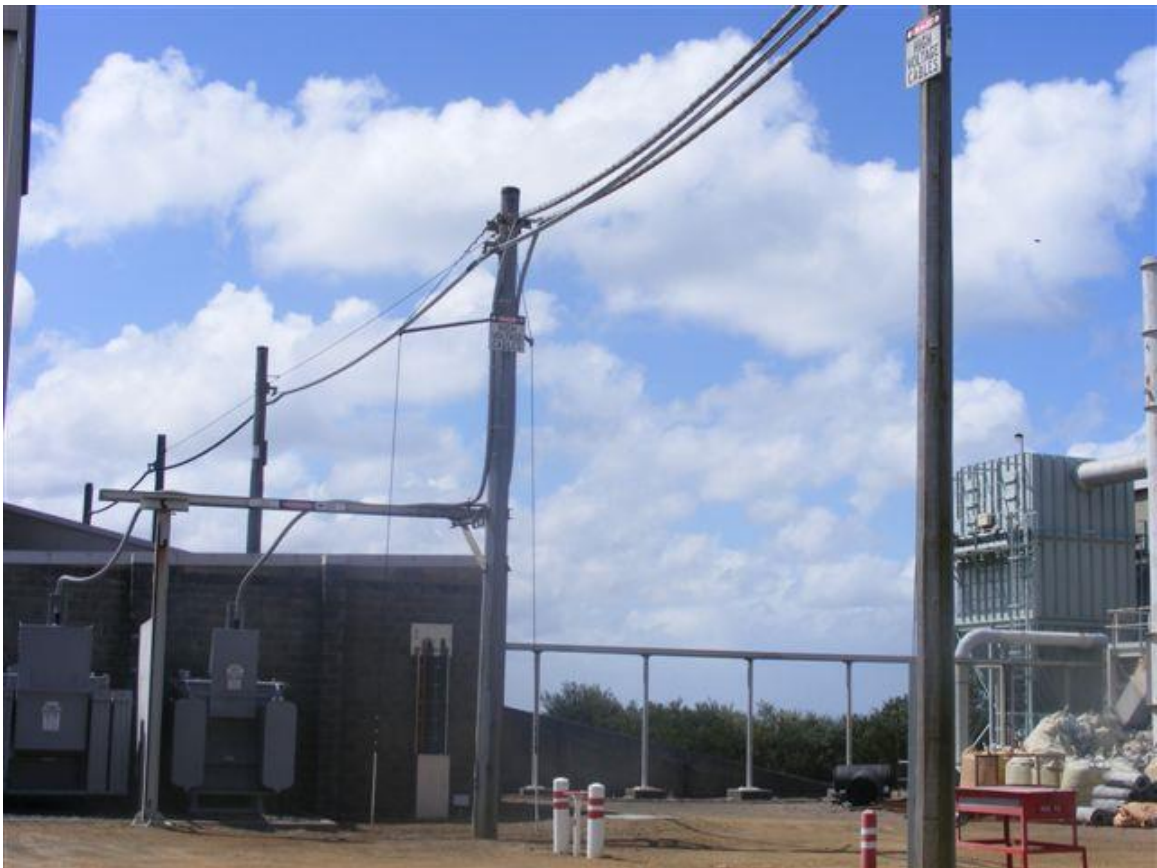
**PORTLAND 22kV AERIAL LINES SHOWING THE INSULATED CABLE CONSTRUCTION AND LACK OF SIGNIFICANT VEGETATION**

Due to the design and layout of the 22kV Distribution system the likelihood of bushfire initiation from conductor failure is remote. Thermographic inspections are undertaken twice yearly to locate any “hot joints” for the cable connections and switchgear within the switchyard where open construction is used.
